Manhole Inspection Summary

Manhole # S07KK1026MH

Insp Date: **1/20/09 2:54 PM**

Location Address: **4827 REISTERSTOWN RD** Cross Street: **MANCHESTER**

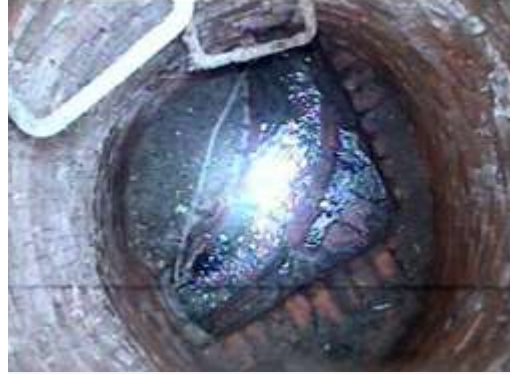
Top View

Steps Count: **3** Missing: **0** ☒ **Corroded**

CORRODED STEP.

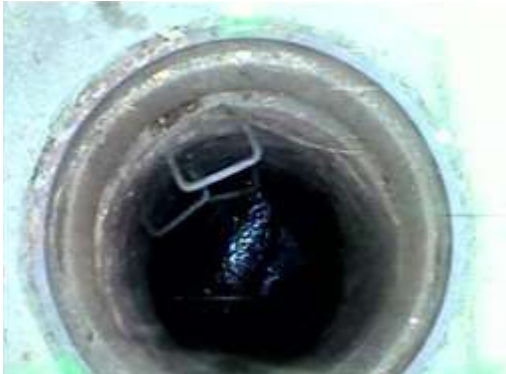
Top View

Frame Offset: **1** (in.) Condition: ☒ Sound ☐ Cracked ☐ Leaks

FRAME OFFSET.

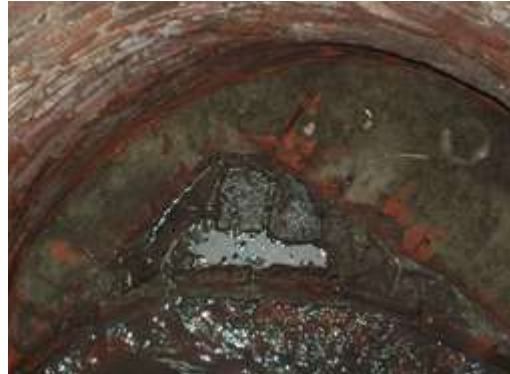
Defect 2

Condition: ☐ Sound ☐ Cracked ☐ Root Intrusion ☒ **Deteriorated** ☐ Leaks ☐ Debris

BENCH AND CHANNEL
DETERIORATION

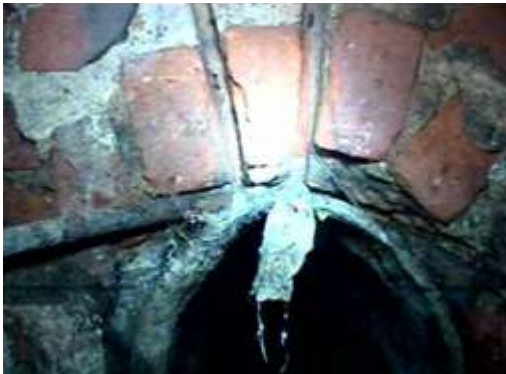
Defect 1

VOID ABOVE O12 SEAL

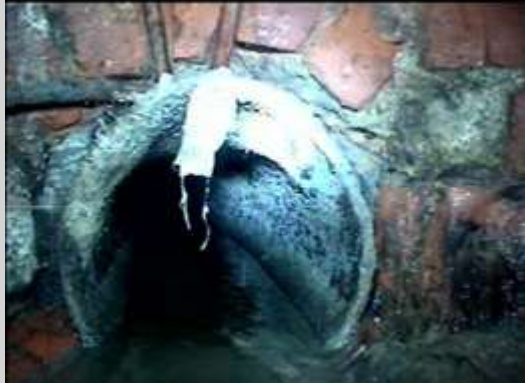
12 O'Clock Outflow

8 in. Circular Gravity Sewer
Pipe Out @ 12 O'Clock

Pipe Height: (in.) Direct
Pipe Material: **Clay** ☐ Pipe Lined
Invert Depth: **7.22** (ft.) Flow Characteristics: **Slow**
Deposits: ☐ None ☐ Mud ☐ Sludge ☐ Debris ☒ **Grease**
Silt Depth: **0.25** (in.) Deposits Extent: **Light**
Infiltration: **None** Pipe Seal Cond: **Broken**

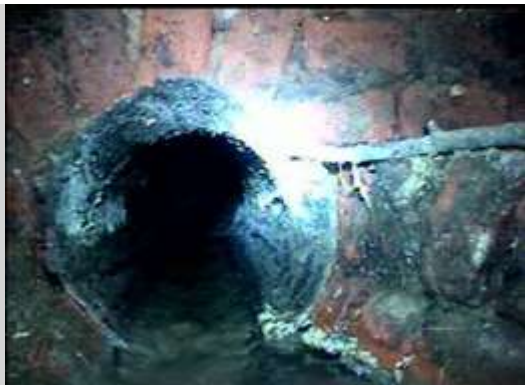
7 O'Clock Inflow

8 in. Circular Gravity Sewer
Pipe In @ 7 O'Clock

Pipe Height: (in.) Direct
Pipe Material: **Clay** ☐ Pipe Lined
Invert Depth: **7.20** (ft.) Flow Characteristics: **Slow**
Deposits: ☐ None ☐ Mud ☐ Sludge ☐ Debris ☒ **Grease**
Silt Depth: **0.25** (in.) Deposits Extent: **Light**
Infiltration: **None** Pipe Seal Cond: **Sound**
